**DEPARTMENT OF TRANSPORTATION****DIVISION OF ENGINEERING SERVICES**

Contract #: 04-0120F4Cty: SF/ALA Rte: 80 PM: 13.2/13.9File #: 69.28**WELDING INSPECTION REPORT****Resident Engineer:** Pursell, Gary**Address:** 333 Burma Road**City:** Oakland, CA 94607**Report No:** WIR-014340**Date Inspected:** 24-May-2010**Project Name:** SAS Superstructure**OSM Arrival Time:** 700**Prime Contractor:** American Bridge/Fluor Enterprises, a JV**OSM Departure Time:** 1900**Contractor:** Zhenhua Port Machinery Company, Ltd (ZPMC), Changxing Island **Location:** Shanghai, China**CWI Name:** Chen Shi Gang**CWI Present:** Yes No**Inspected CWI report:** Yes No N/A**Rod Oven in Use:** Yes No N/A**Electrode to specification:** Yes No N/A**Weld Procedures Followed:** Yes No N/A**Qualified Welders:** Yes No N/A**Verified Joint Fit-up:** Yes No N/A**Approved Drawings:** Yes No N/A**Approved WPS:** Yes No N/A**Delayed / Cancelled:** Yes No N/A**Bridge No:** 34-0006**Component:** Bay 9 and 12**Summary of Items Observed:**

## WELDING INSPECTION REPORT

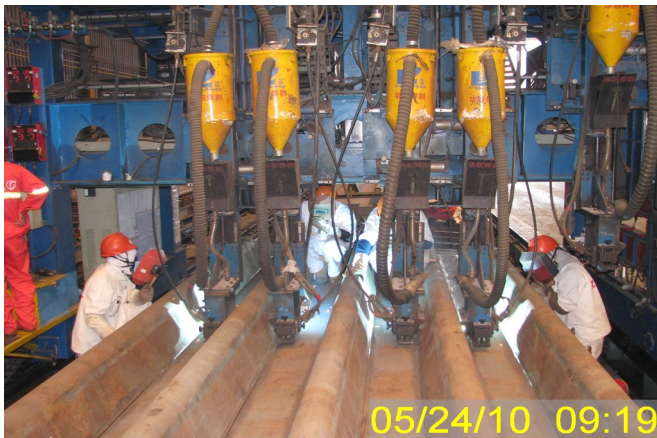
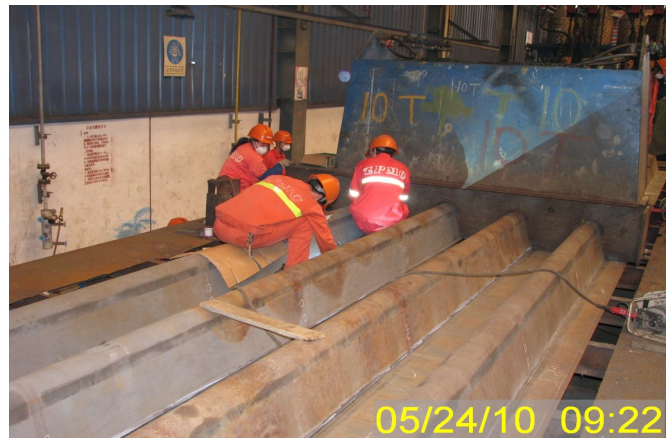
This QA Inspector observed ZPMC welding personals identified as 059440 and 059373 performing Gas Metal Arc welding (GMAW) tack welding on DP3112-001 deck plate to U-rib. ZPMC QC is identified as Zhu Zhong Jie. The welding variables recorded by QC appeared to comply with the WPS-345-B-T-2342 U5b (U-Rib).

This QA Inspector observed ZPMC welding personals identified as 059464 performing Flux Cored Arc welding (FCAW) on DP3180-001 U-rib internal stiffeners. ZPMC QC is identified as Zhu Zhong Jie. The welding variables recorded by QC appeared to comply with the WPS – B – T – 2133 and WPS – B – T – 2233 – Tc – U4b – F (CJP)
